Quality Assurance Audit Report
Technical Systems Audit
Sinclair Wyoming Refining Company
Ambient Air Monitoring Program
May 22-29, 2019

U.S. Environmental Protection Agency
Region 8

Executive Summary

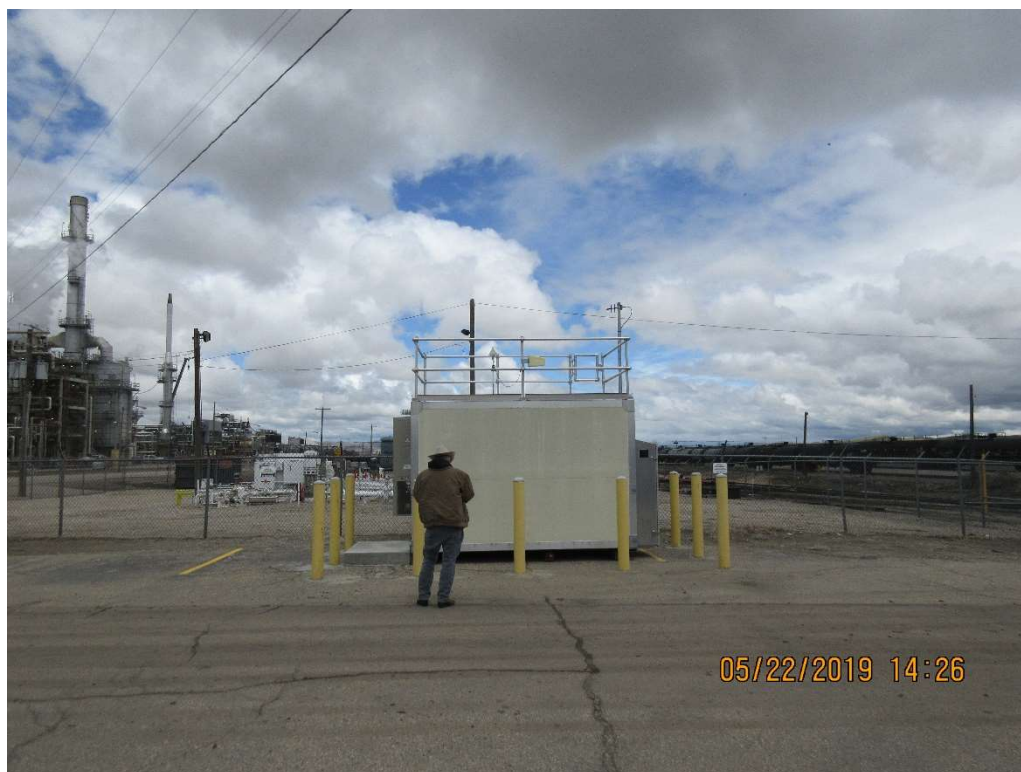
Figure 5. South West Ambient Air Monitoring Station (Facing East)

1)	It appears the South West station needs more frequent maintenance.
2)	The monitoring shelters are missing documentation and contain obsolete documentation.

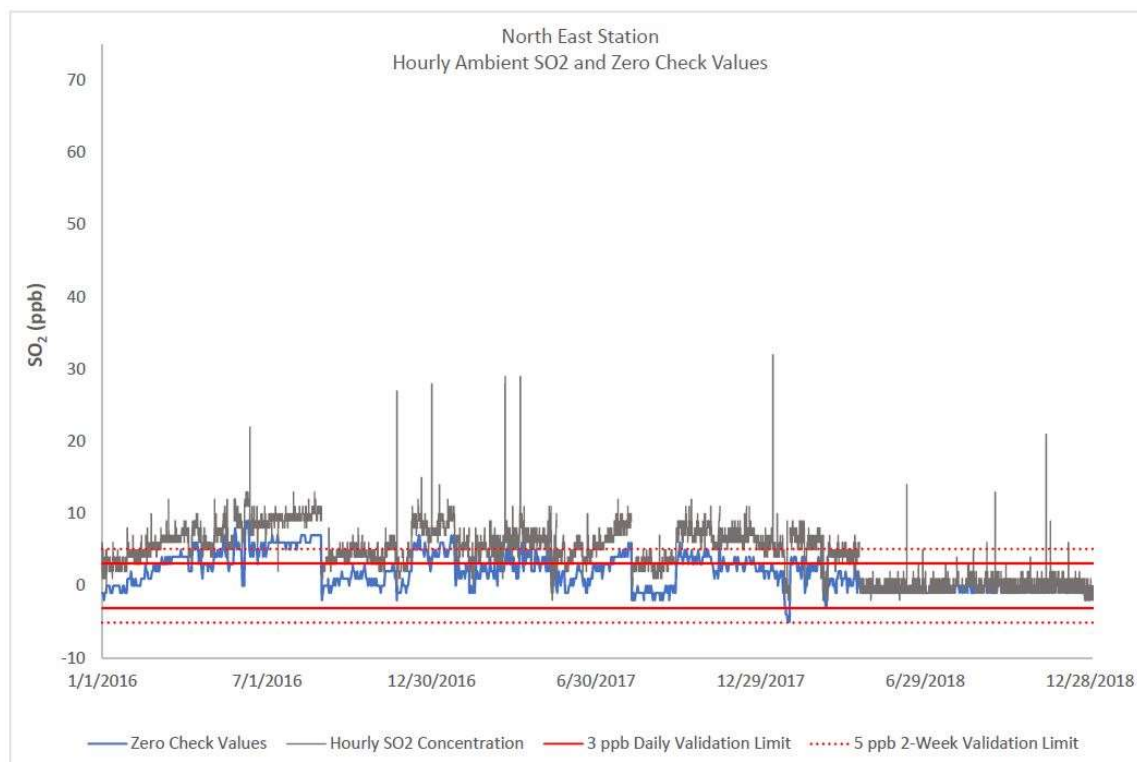
Review of the 2016, 2017, and 2018 quarterly data reports revealed periods of data where the zero checks exceeded the QMP/QAPP and validation template acceptance criteria (Figures 6, 7, 8, and 9). The data associated with these bad QC checks were not invalidated or otherwise flagged. The majority of these acceptance limit exceedances were at the North East site, but exceedances were noted at the In-Town Station as well.

As shown in Figure 6, the North East Station had numerous occasions where the SO₂ zero-check values fell well above 3.1 ppb. The analyzer was allowed to operate like this for weeks (and sometimes months) at a time. A number of checks even fall above 5.1 ppb, which would be the limit for biweekly checks. The effect on the data is obvious from the plot. The hourly SO₂ concentrations have a direct and proportional relationship with the zero-check results. The NO_x analyzer also had exceedances of the data validation limits (Figure 7), although the excursions occurred over shorter periods than for the SO₂.

Zero and span checks are critical criteria in the data validation template. This means that when the acceptance criteria are exceeded the data should be invalidated unless compelling evidence to the contrary exists. None of the routine data associated with the identified failing checks are flagged or invalidated in AQS.

Figure 6. North East Hourly Ambient SO₂ and Zero Check Values

Recommendation: The QMP/QAPP needs to spell out how the team keeps analyzers in control. This typically consists of identifying and implementing an action limit that is less than the acceptance criteria. The QMP/QAPP should specify what actions are taken to correct the issue when action limits are reached and how the data will be validated or invalidated when acceptance criteria are exceeded.

Additionally, due to the lack of evidence to demonstrate all the SO₂ data at the North East Station are of acceptable quality, all data with failing zero-checks should be invalidated in AQS unless there is compelling evidence that the data are of acceptable quality. Data invalidation should also be performed for the other stations and analyzers affected by this finding.

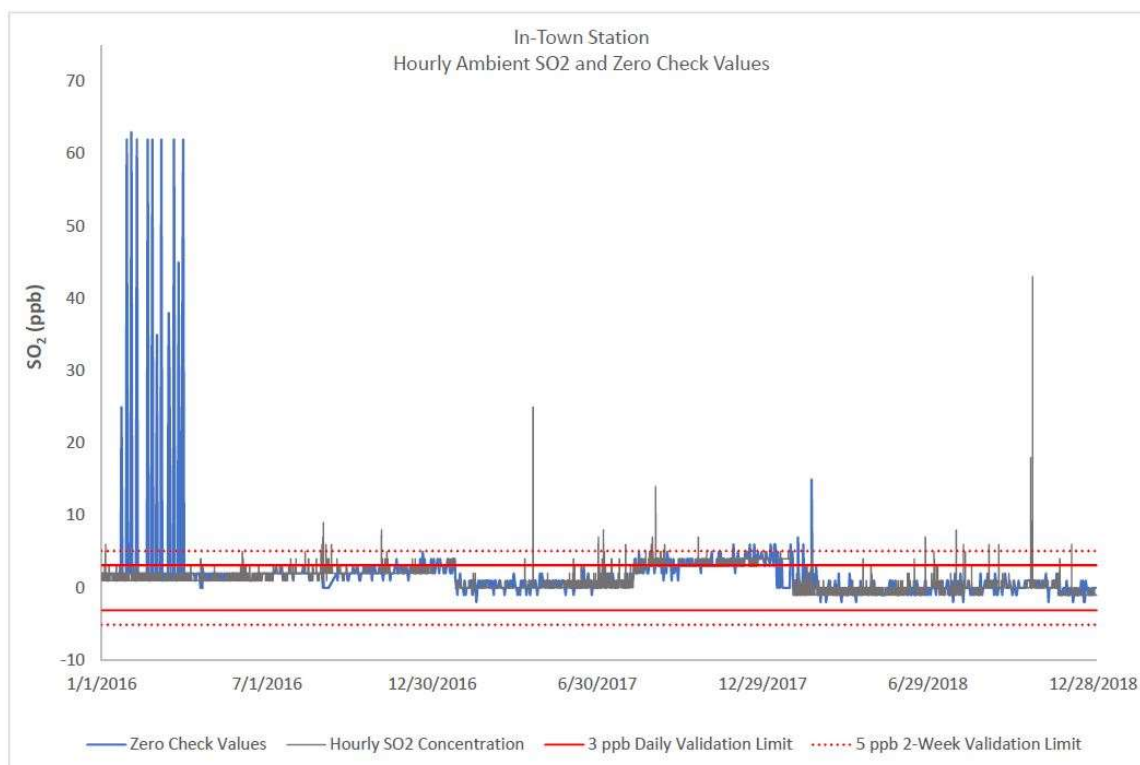
Figure 7. In-Town Hourly Ambient SO₂ and Zero Check Values

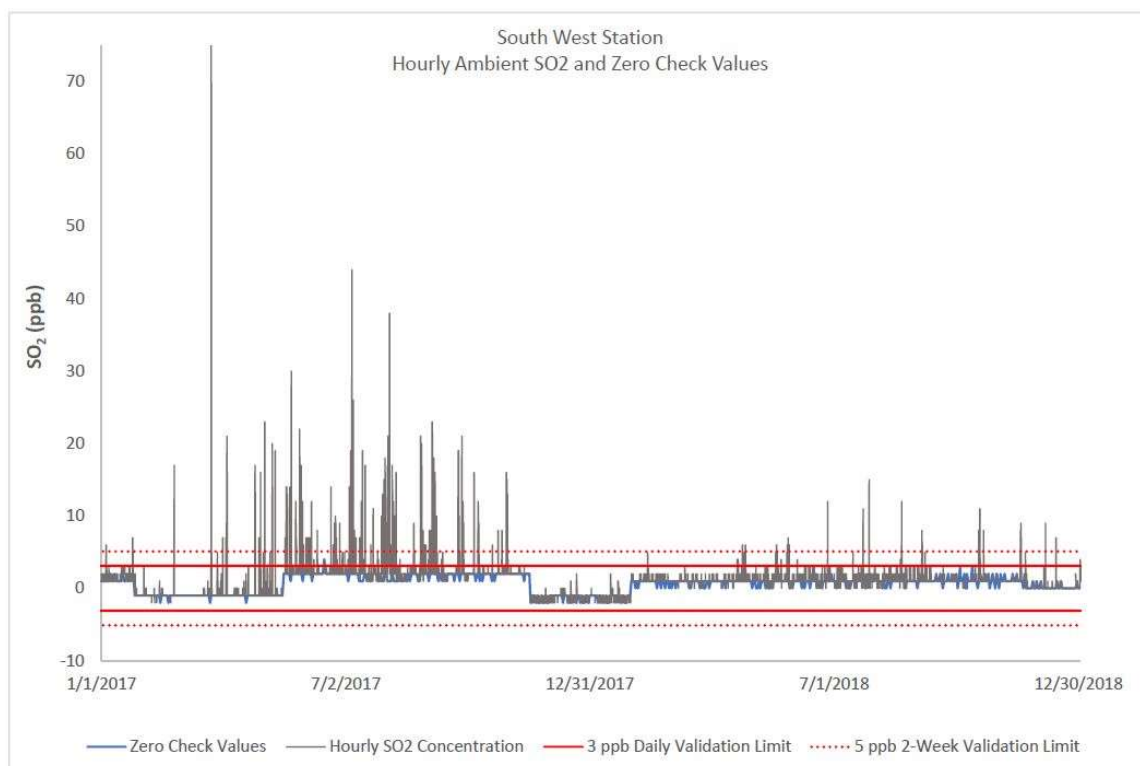
Figure 8. South West Hourly Ambient SO₂ and Zero Check Values

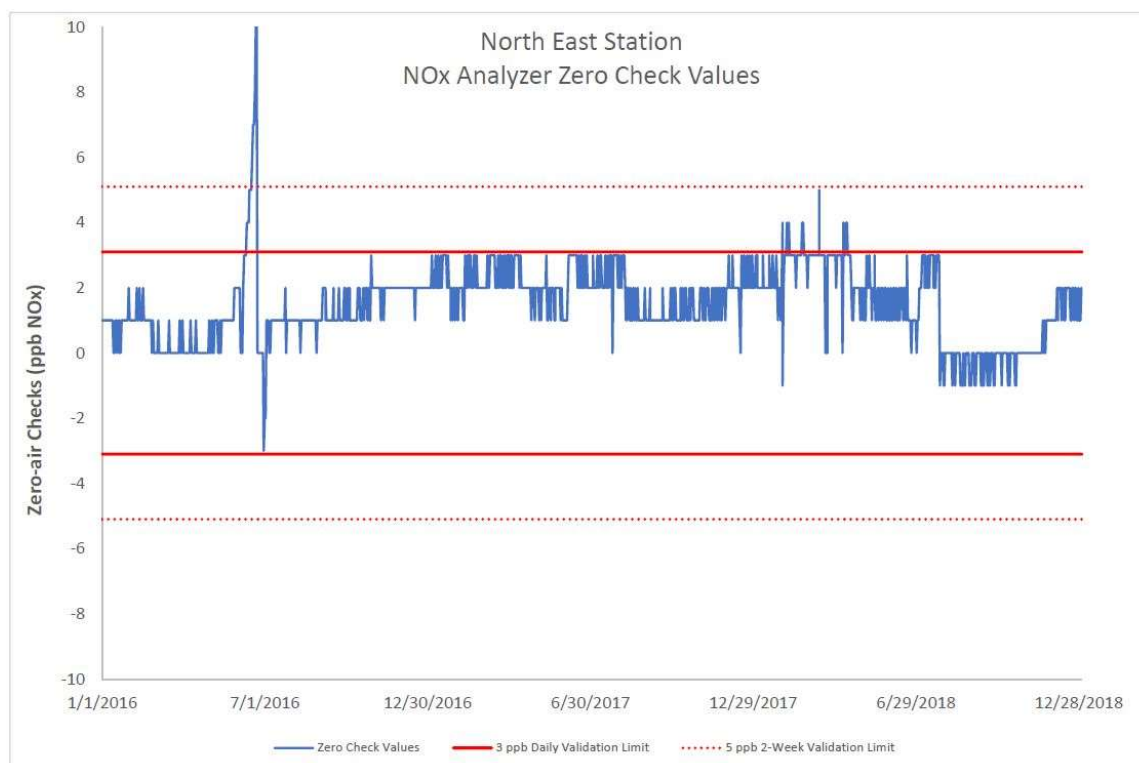
Figure 9. North East Ambient NOx Zero Check Values

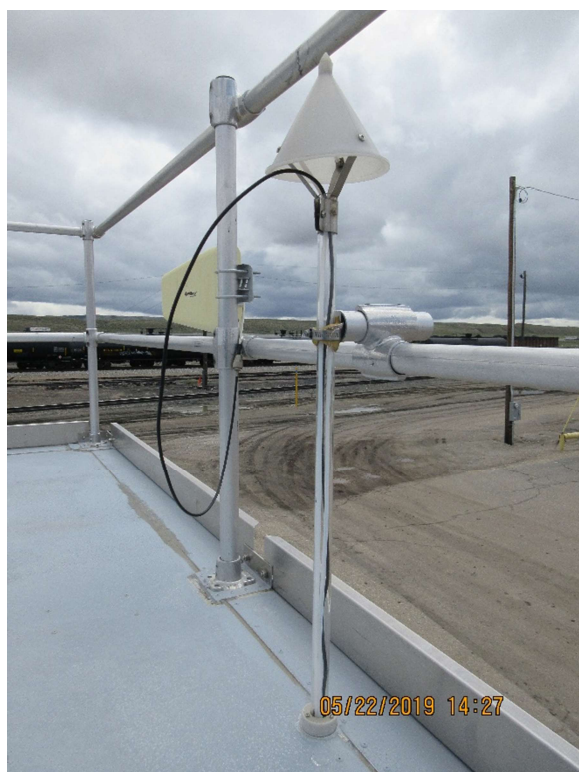
The gaseous inlet was too close to the shelter at the South West monitoring station (Figure 10). Table E-4 of appendix E to 40 CFR part 58 states that "Horizontal and vertical distance to supporting structures to probe inlet, or 90% of monitoring path must be greater than 1 meter." The South West station inlet was found to be 0.78 m above the roof of the shelter. This measurement was taken from the bottom of the rain shield to the roof, as this is where the ambient air enters the sample train.

The auditors identified several unacceptable materials in the sample train. The South West site has quarter inch teflon that extends up into a Sabio funnel made from polyethylene (Figure 10 and 11). Since the sampling probe extends into the rain cover, all materials in this cover must also be borosilicate glass or FEP Teflon. The North East site has screen material in the inlet housing (Figure 12). In addition, there are stainless steel T's in this inlet housing and in the sample lines.

Figure 10. The inlet at the South West Station.

Recommendation: Sinclair should raise the inlet so that it is at least one meter above the supporting structure.

Recommendation: Sinclair should replace all material in the inlet or sample train that is not borosilicate glass or FEP Teflon. This may require adjusting or installing new inlets at all three sites. Please send the manufacturer's information on the North East and In-Town station covers to the auditors or replace the current setup with appropriate materials.

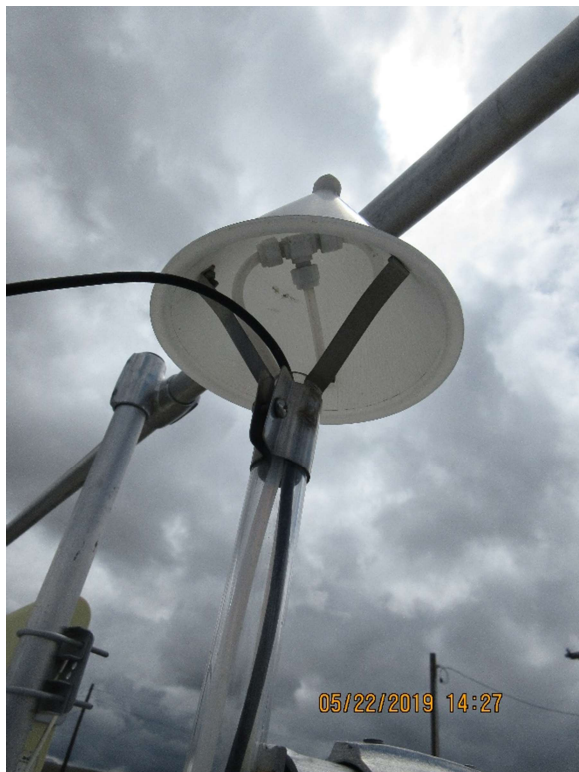
Figure 11. The inlet configuration at the South West Station.

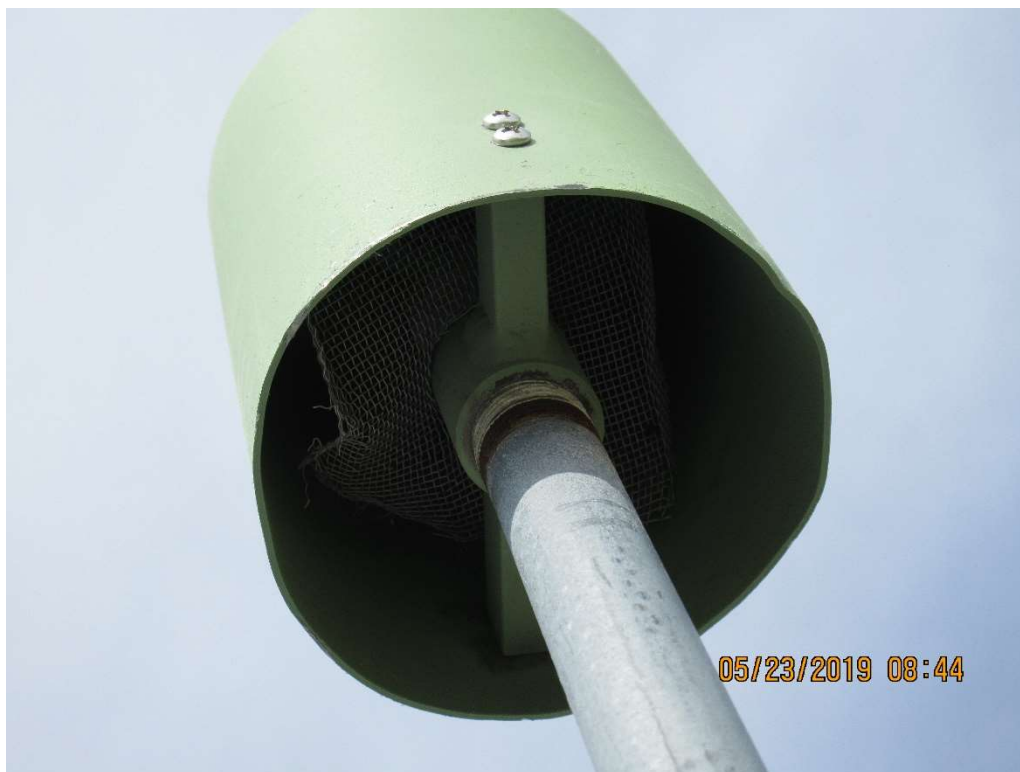
Figure 12. The inlet and screen material at the North East Station.

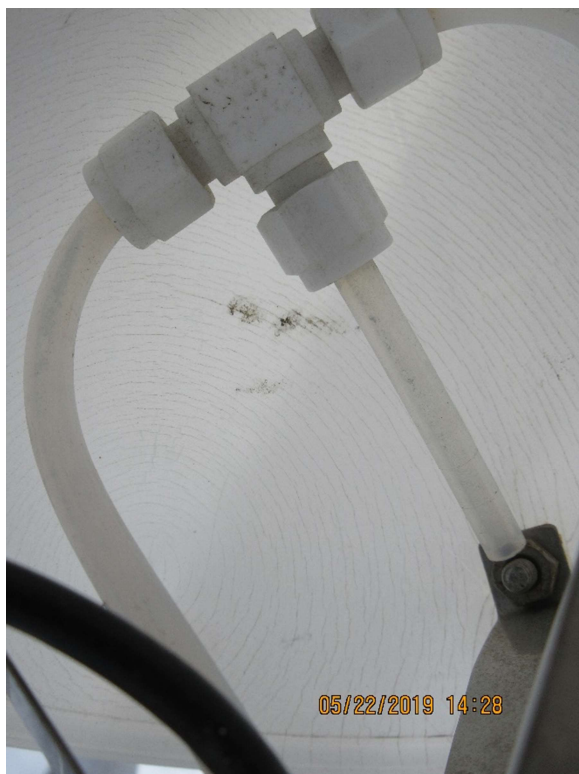
Figure 14. The inlet line to the South West station. Dirt is visible inside the quarter inch Teflon lines.

Recommendation: The onsite technicians should be trained on how to determine if the filters or lines need to be replaced (see Minor Finding 7). AECOM employees should inspect the inlet each visit and make sure the sample lines are clean. If not, they should be replaced. The South West lines should be replaced as soon as possible.

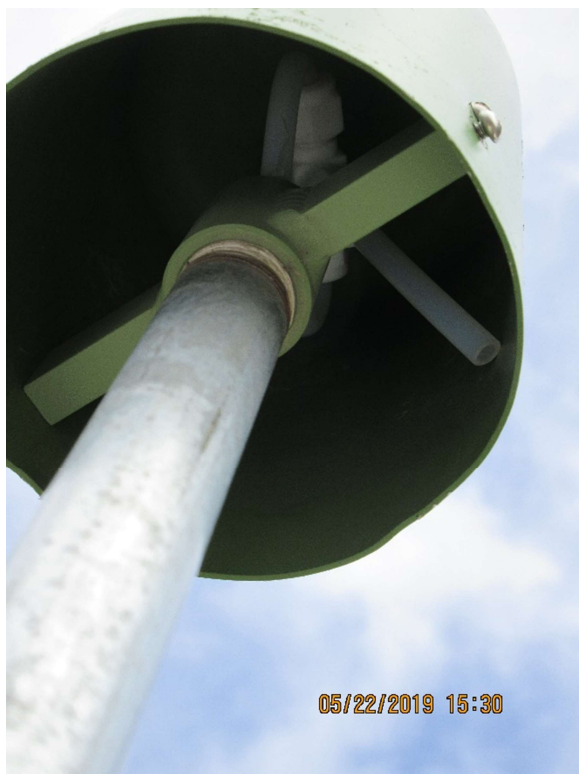
Figure 15. The sample line at the In-Town Station.

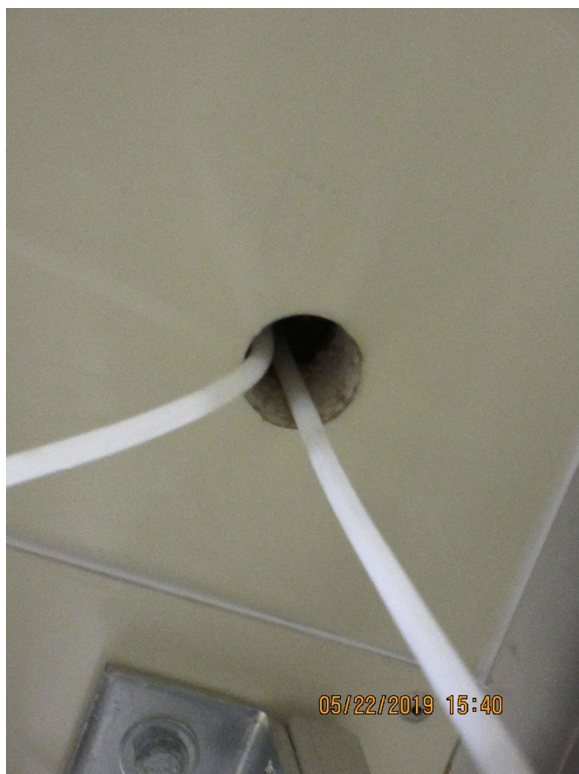
Figure 16. Where the sample and calibration lines enter the conduit on the roof of the In-Town Station.

Recommendation: All conduit carrying sampling lines should be plugged to prevent any shelter air from being forced up the conduit and inadvertently sampled.
